BELZONA 5811 PROTECTS NEW TRASH RACKS AT A HYDRO PLANT

ID: 5979

Customer Location: Paris, ON, Canada
Application Date: December 2015

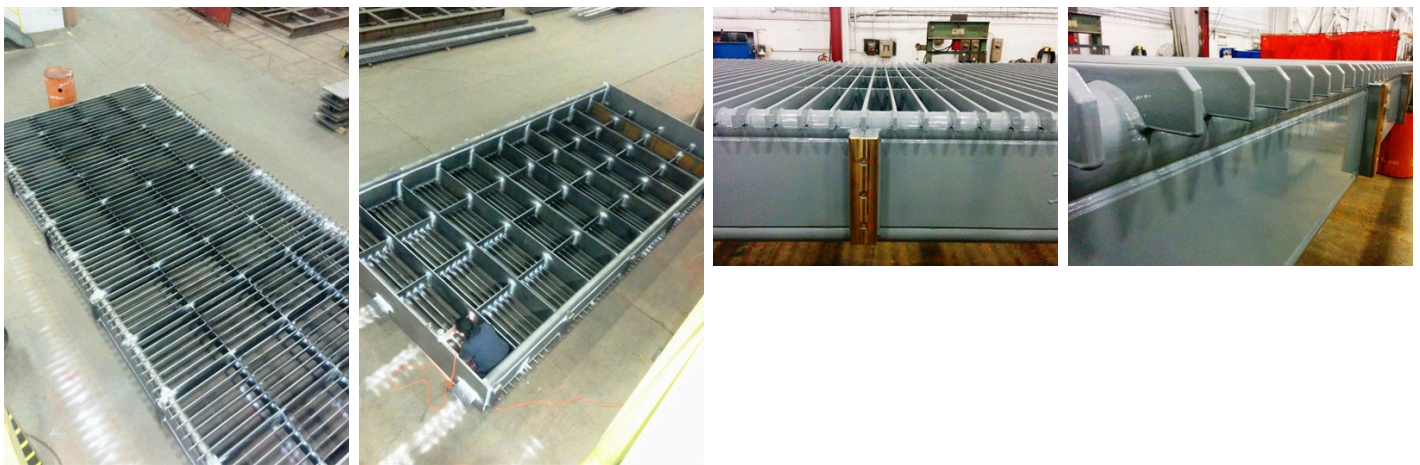
Photograph Descriptions

- * Fabricated trash rack with metal grating ,
- * Fabricated trash gate undergoing NDT inspection to welded joints ,
- * Belzona 5811 spray applied ,
- * Close up of Belzona 5811 spray applied to grating ,

USACE is developing a new hydroelectric facility and part of the project involves the manufacture of 16 sections of trash rack. Each piece has a surface area of approximately 1100 sq.ft. The Hydroelectric Project is licensed at 36.4 megawatts (MW) of electricity, or enough energy to meet the needs of about 18,000 homes. The newly manufactured trash racks were specified to be protected from corrosion using Belzona 5811.

High volume airless plural spray system
