# TOUGH AND LASTING BELZONA PROTECTION FOR PUMP IN DESULFURIZATION UNIT

ID: 5981

Application: SHM-Solids Handling Machinery

Customer Location: Power Plant, La Spezia, Italy

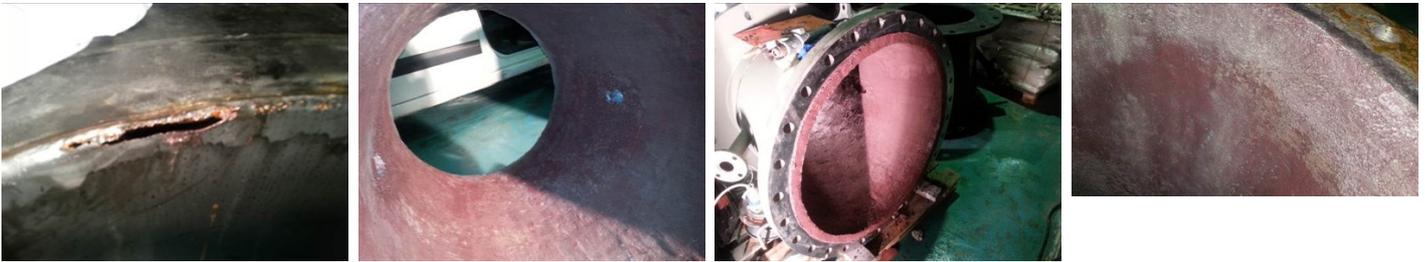
## Photograph Descriptions

The cone was suffering from severe dry abrasion in the presence of strong concentrations of sulfides. Previously applied rubber coating started to peel, leading to leakages between flange couplings. Leaking corrosive substance in turn attacked the underlying metallic substrate, thus reducing the efficiency and the working life of this component.

- \* Original holed rubber lining ,
- \* Application of Belzona 1811 ,
- \* Application of Belzona 1811 ,
- \* Inspection after 1 year in service ,

The application was carried out in accordance with Belzona Know-How System Leaflet SHM-13. The failed rubber coating was removed, the substrate was then grit blasted and a thick layer of Belzona 1811 was applied to protect the cone from further abrasion damage.

This Belzona solution succeeded where a competitive system had failed. After a year in service, Belzona 1811 is still in a as new condition, to the customer's delight. The Belzona solution effectively enhanced efficiency and the working life of this component.
