BELZONA WITHSTANDS PROLONGED WET ABRASION

Industry: *Pulp & Paper*
 Application: *CEP-Centrifugal Pumps*
 Substrate: *Carbon Steel*
 Products: ** Belzona 5811 (Immersion Grade) ,*
** Belzona 1321 (Ceramic S-Metal) ,*
** Belzona 1311 (Ceramic R-Metal) ,*

Customer Location: *Paper Mill, Turin, Italy*
 Application Date: *July 2012*

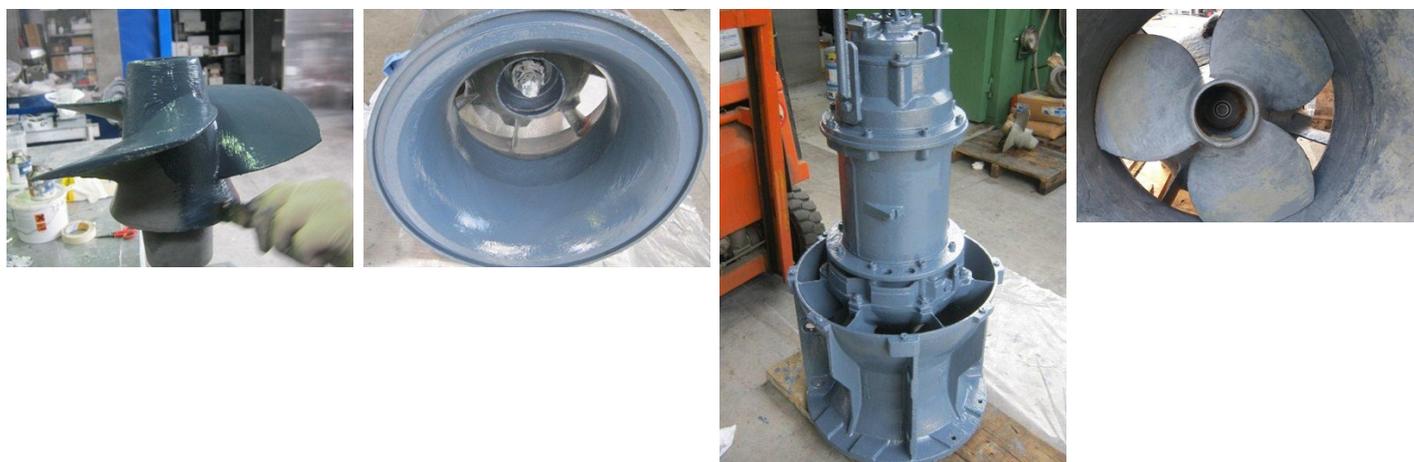
Photograph Descriptions

Due to severe abrasion and corrosion, the components' lifetime was very short. Pump and its components had to be replaced every 2/3 years.

- * Pump impeller being coated ,
- * Pump lining applied ,
- * External coating applied ,
- * Inspection after 4 years in service ,

The application was carried out in accordance with Belzona Know-How System Leaflets CEP-3, CEP-4 and CEP-5. Surface preparation was carried out using grit blasting. Pitted and eroded areas were rebuilt with Belzona 1311, the internal surfaces were then coated

with Belzona 1321 to protect the pump from erosion-corrosion. Belzona 5811 was then used to protect the external surfaces of the pump.

The Belzona solution successfully withstood wet abrasion and managed to significantly prolong the life of this pump. After 4 years in service, the pump was inspected and found to be in perfect condition, with the Belzona coatings predominantly intact. These 4 years of stress-free operation amounted to significant savings due to the absence of maintenance and downtime. The length of maintenance-free time has now been doubled and instead of scrapping the whole pump, customer only needs to replace the coating.
