BELZONA PROVIDES NON-SLIP SURFACE TO TRANSFER ROLLER

ID: 5996

Application: SHM-Solids Handling Machinery

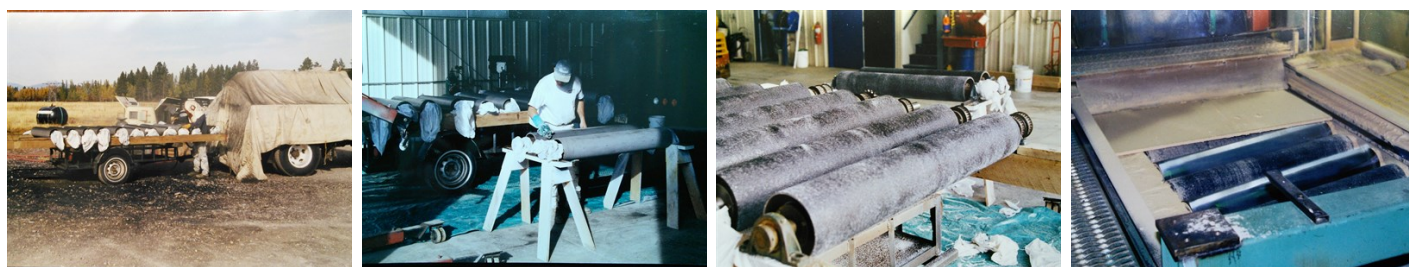
Photograph Descriptions

Transfer rollers that move boards downstream of platen press are smooth, causing lack of traction to keep line running.

- * Achieving a proper blast profile. ,
- * Belzona 9111 to clean and degrease before and after blasting. ,
- * Transfer rollers curing after coating and aggregate applied. ,
- * Transfer rollers installed and keeping the line going. ,

The application was carried out in accordance with the IFU for Belzona 5811. The coating was brush applied and the aggregate was spread by hand.
