BELZONA ENSURES SAFETY ON WASTE MANAGEMENT TRUCKS

ID: 6000

Industry: *Transport*
Application: *FPA-Floor Problem Areas*
Substrate: *Carbon Steel*
Products: ** Belzona 1321 (Ceramic S-Metal) ,*
** Belzona 9211 (Supergrip Aggregate) ,*

Customer Location: *Montana, USA*
Application Date: *2003*

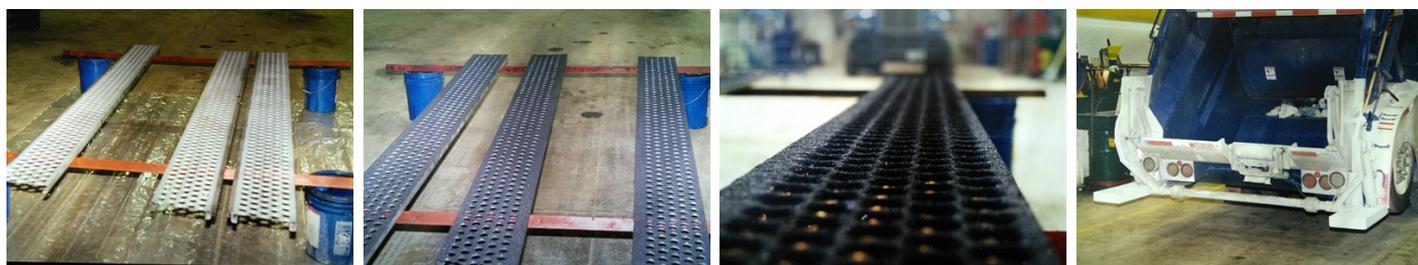
- * Surface preparation on full length stair treads ,
- * Non-Slip application completed on stair treads ,
- * Close up of an aggressive texture of the application ,
- * Steps installed on one of the garbage trucks ,

The application was carried out in accordance with a modified version of Belzona Know-How System Leaflet FPA-8 and Belzona Instructions For Use.

Because of the excellent adhesion of Belzona 1321, it was the right material to hold Belzona 9211 in place. The product is also durable enough to withstand the cleaning of the steps in winter when snow and ice accumulated. The application to bulk stair

treads allowed for cutting and installing as needed without reapplication. The dependability of this non-slip surface saved the workers from personal injuries as well as the company from loss time and incidents.
