# BELZONA PROTECTS HOG FUEL SCREW CONVEYOR

ID: 6009

Industry: Pulp & Paper  
Application: SHM-Solids Handling Machinery

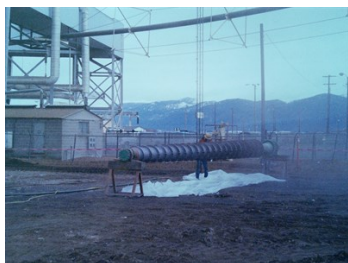
- \* Grit Blasting of auger ,
- \* Belzona 1812 applied to base of flighting ,
- \* Shipping wrap placed over Belzona 1812 to smooth surface ,
- \* Full length of auger protected and improved ,

The application was carried out in accordance with Belzona Know-How System Leaflet SHM-14 and Belzona product Instructions For Use.
