MORE THAN 500 FLANGES ENCAPSULATED WITH BELZONA

ID: 6011

Customer Location: Gas Supplier, Oman
Application Date: December 2015

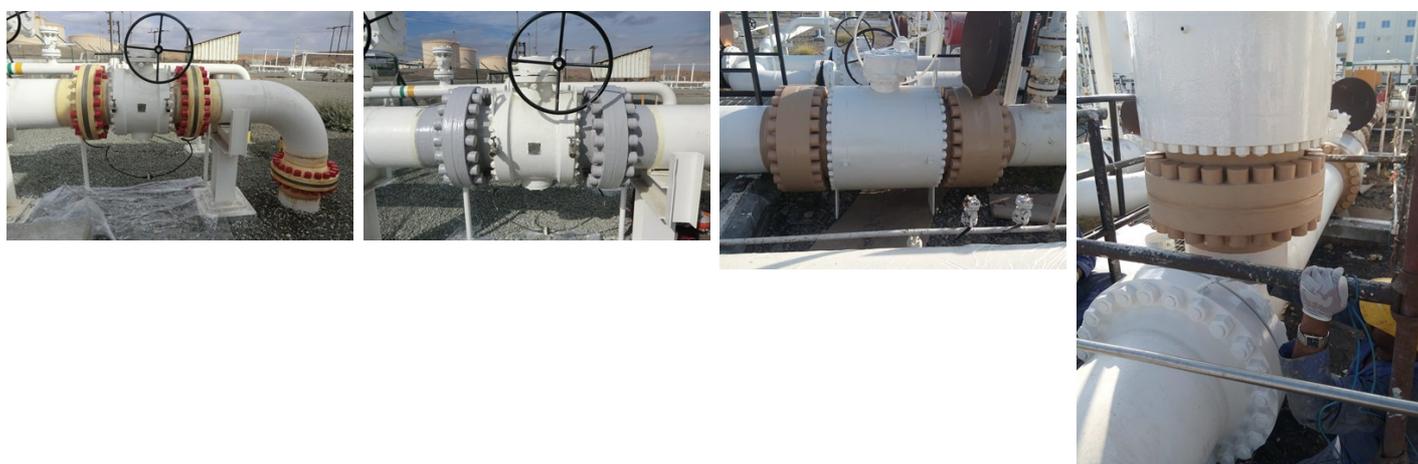
Photograph Descriptions

- * Substrate ready for application with bolt covers, bridging tape and application of Belzona 8411 ,
- * Application of base coat of Belzona 3411 ,
- * Application completed with second coat of Belzona 3411 ,
- * Completed applications on several flanges ,

The application was carried out in accordance with Belzona Know-How System Leaflet GSS-11.
