BELZONA PLATE BONDING SOLUTION SEALS STEEL PLANT GAS LEAKS

ID: 6012

Customer Location: Steel Plant, Sweden
Application Date: October 2015

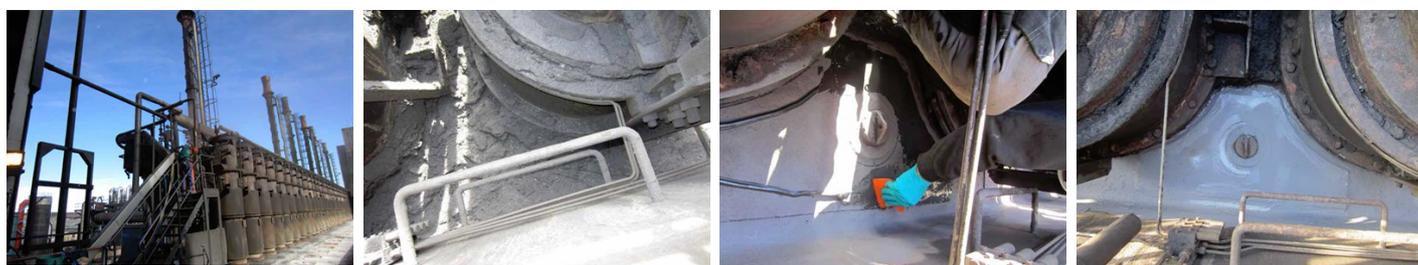
Photograph Descriptions

- * View of steel plant furnaces with corrosion problems ,
- * Heavily corroded base underneath the debris ,
- * Applying Belzona 1251 to prepared area ,
- * Completed application after coating with Belzona 5851 ,

Significant number of gas leaks around the coke ovens threatened fines and closure of the plant from the environmental authorities.

The application was carried out in accordance with Belzona Know-How System Leaflet VPF-11. After cleaning and grit blasting the leaking areas, custom designed plates were bonded into place with Belzona 1251, Belzona 5851 was then coated over the top for further protection.

Welded plates were not possible due to hot work restrictions in this area of the plant. The Belzona solution offered a fast/safe solution that was carried out without the need to shut the plant down.
