BELZONA STATIC DISSIPATIVE LINING FOR CHEMICALLY AGGRESSIVE ENVIRONMENT

ID: 6016

Industry: Chemical & Petrochemical
Application: TCC-Tanks and Chemical Containment Areas

Customer Location: Refinery, France

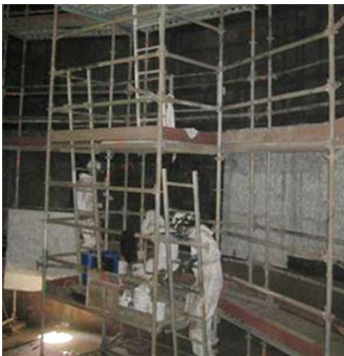
* 1. Scaffolding assists Belzona 4311 application
2. First layer of Belzona 4311 applied
3. Application of the lining on the floor
4. Application of Belzona 4351 completed ,

The application was carried out in accordance with Belzona Know-How System Leaflet TCC-5. After thorough surface preparation, a two layer system of Belzona 4311 was applied throughout the tank. Finally, across the tank's entire bottom and half a metre up the walls, the application was finished with a coat of Belzona 4351. Note that Belzona 4351 was sufficiently grounded.

Scaffolding was installed allowing for safe and effective application even at the full height of the tank. This solution reduced downtime, meaning the tank could be put into service in a very short time. Belzona system provided the required level of acid resistance combined with the need for static dissipation.
