# BELZONA STATIC DISSIPATIVE SOLUTION APPLIED TO SILO

ID: 6017

**Customer Location:** Bio-fuel Producer, Mannheim, Germany  
**Application Date:** November 2011 - February 2012

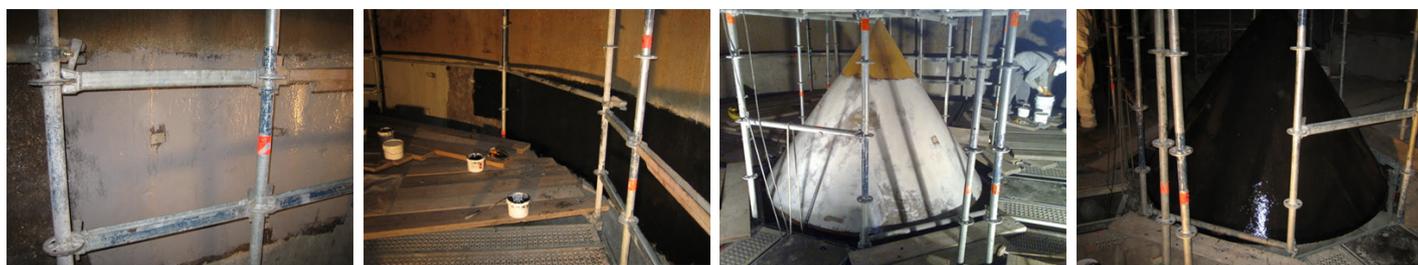
Some of the internal walls and steel cones needed repairing. In addition, a static dissipative coating was required to protect against static build up within the silo.

- \* Earthing points left exposed in restored silo wall ,
- \* Section of silo coated in Belzona 4351 ,
- \* Silo cone repaired and left with earthing points ,
- \* Silo cone coated with Belzona 4351 ,

Application was carried out in accordance with Belzona Know-How System Leaflets TCC-3. Damaged concrete was repaired with Belzona 4111. Belzona 4351 was applied to walls and cone taking care to ensure Belzona 4351 was in direct contact with the earthing points provided.
