# OIL COOLERS PROTECTED WITH BELZONA

ID: 6039

Industry: Oil & Gas  
Application: HEX-Heat Exchangers  
Substrate: Carbon Steel  
Products: \* Belzona 1121 (Super XL-Metal) ,  
\* Belzona 1321 (Ceramic S-Metal) ,

Customer Location: Deer Park, TX, USA  
Application Date: March 2016

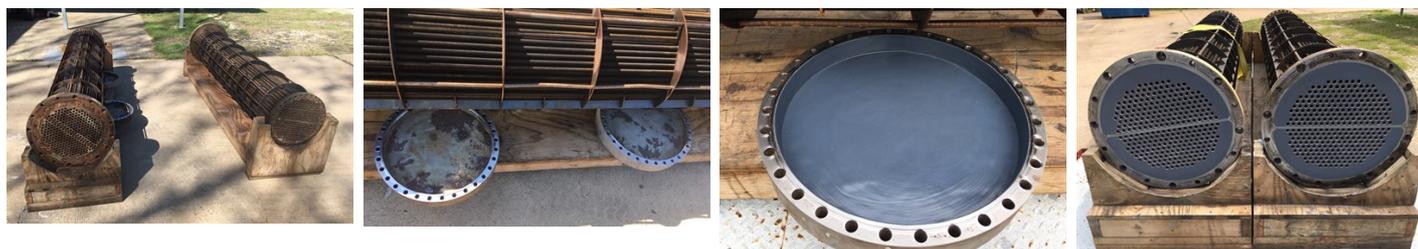
The customer was getting cross contamination between process cooling water and process lubricating oil, due to the corrosion at the copper tube and carbon steel tube sheet interface.

- \* Chillers derived with pitting on tube sheet face. ,
- \* Picture of end covers with pitting. ,
- \* Finished end covers with final coat of Belzona 1321. ,
- \* Repaired tube sheets with Belzona 1121 and Belzona 1321. ,

The tube sheets and end covers of heat exchangers used for oil cooling were suffering from corrosion.

The application was carried out in accordance with Belzona Know-How System Leaflet HEX-1. First, all of the tubes were corked. Then the surface of tube sheets and end covers were blasted. The tube sheet was then rebuilt flush and the pitting on end covers were filled in with Belzona 1121. All surfaces were coated with 2 coats of Belzona 1121 as per IFU.
