# BELZONA PROVIDES LONG-TERM SOLUTION FOR SPALLED CONCRETE

Application: WPA-Wall Problem Areas

Customer Location: School, Essex, UK

Application Date: March 2016

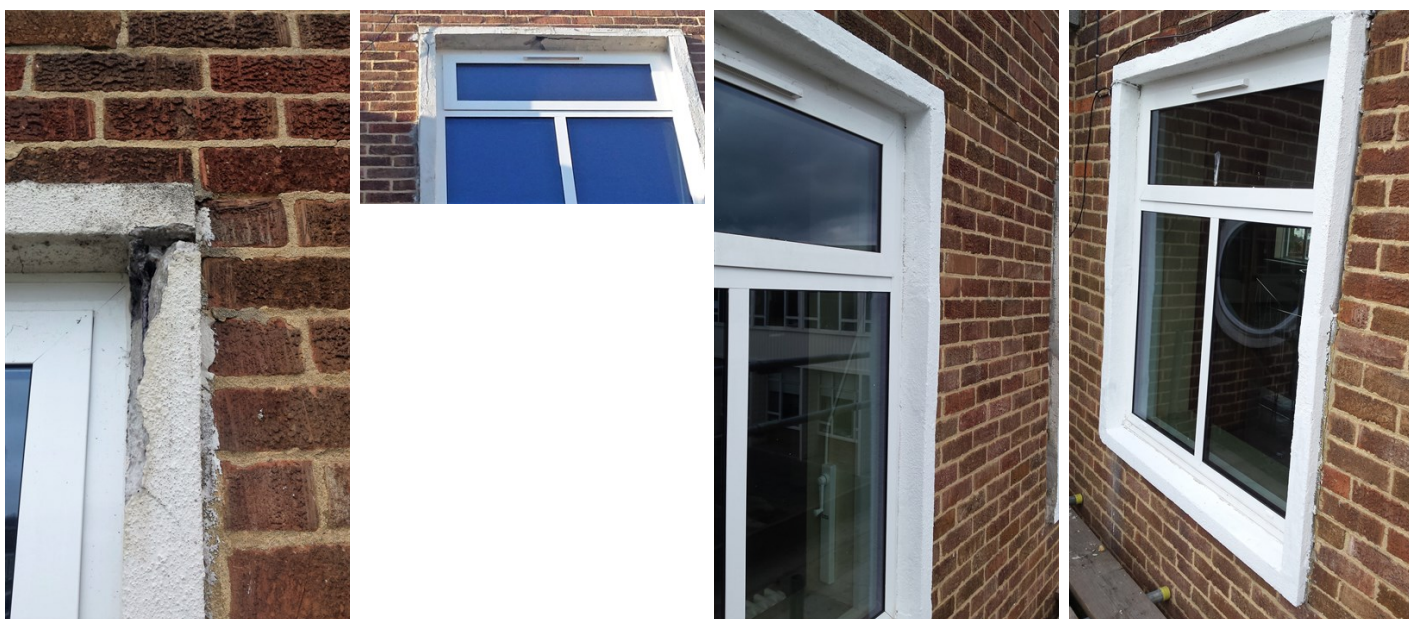
## Photograph Descriptions

When the windows were replaced it became apparent that there were major issues with spalled concrete on many of the window sills and lintels. Large chunks of concrete were breaking away and causing a hazard for staff and pupils. The repairs had to be able to be carried out with minimum disruption to the school's usual activities.

- \* A severely spalled corner piece ,
- \* A cracked and spalled lintel ,
- \* The repaired corner piece ,
- \* The repaired lintel ,

Application was carried out in accordance with Belzona Know-How System Leaflet WPA-4. All loose debris was removed and the area cleaned before applying Belzona 4911 followed by Belzona 4141 to restore the original profiles. No special shuttering was required and the repairs were carried out easily with trowels.
