HEAT EXCHANGER RELIABLY REFURBISHED WITH BELZONA

Industry: Chemical & Petrochemical
Application: HEX-Heat Exchangers
Substrate: Carbon Steel
Products: * Belzona 1511 (Super HT Metal) ,
* Belzona 1391 (Ceramic HT) ,

Customer Location: Petrochemical Plant, Teesside, UK
Application Date: 2009

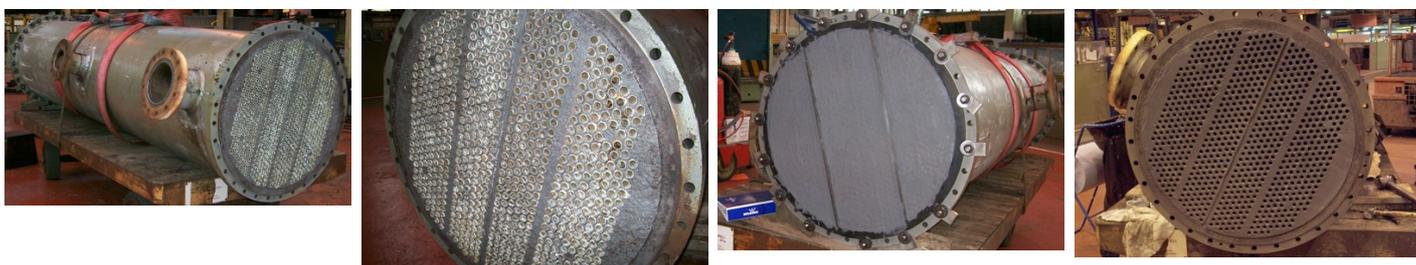
Photograph Descriptions

This Propylene heat exchanger operates at up to 120°C and the tube face had suffered severe galvanic and pitting corrosion. The separator channels and tube face had to be completely rebuilt to prevent bypass of the separator plate. In addition, the client required a lining to prevent further attack to the water boxes, nozzles and the tube faces.

- * Heat exchanger arriving in workshop ,
- * Pitting damage clearly visible after grit blasting ,
- * Tube face being rebuilt ,
- * Belzona application completed ,

Belzona 1511 high temperature resistant paste grade was used to resurface the tube sheet and rebuild the separator channels. All parts of the heat exchanger were then protected with a simple brush application of Belzona 1391 which is capable of withstanding immersion conditions of 120°C. Prior to this work the client was considering a complete replacement of the asset, which would have been at least 12 times the refurbishment costs at that time. The application was in excellent condition when inspected in
