BELZONA SEALS REMOTE PUMP HOUSE FLOORS

ID: 6092

Application: FPA-Floor Problem Areas

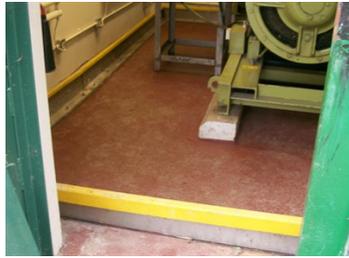
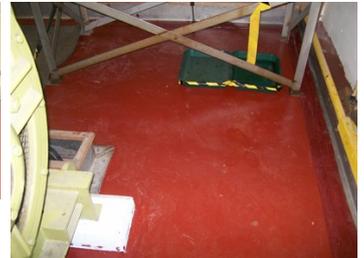
Photograph Descriptions

The client had a series of remote pump houses with diesel storage tanks inside and these facilities were seldom visited. Should there be a leak of diesel, it could be weeks before it was discovered and it was known that the floors would not hold fluids reliably. Previously the floors have been coated with a conventional solvent based paint and angled edging trims had been fixed to the floor to try and create a containment area. Both of which had failed.

- * One of the remote pump houses ,
- * Existing floor during initial inspection ,
- * Belzona 2121 being applied to seal the edging trim ,
- * Application completed in 2011 ,

Application was carried out in accordance with Belzona Know-How System Leaflets FPA-3 and FPA-7. Following surface preparation, 2 coats of Belzona 5231 were applied to the concrete floor. The joint between the steel edging trim and the floor was then sealed by applying a narrow band of Belzona 2121, reinforced with Belzona 9341.
