BELZONA REPAIRS PINHOLES IN HEATER DRUM

ID: 6101

Customer Location: Offshore Platform, Gabon
Application Date: April 2016

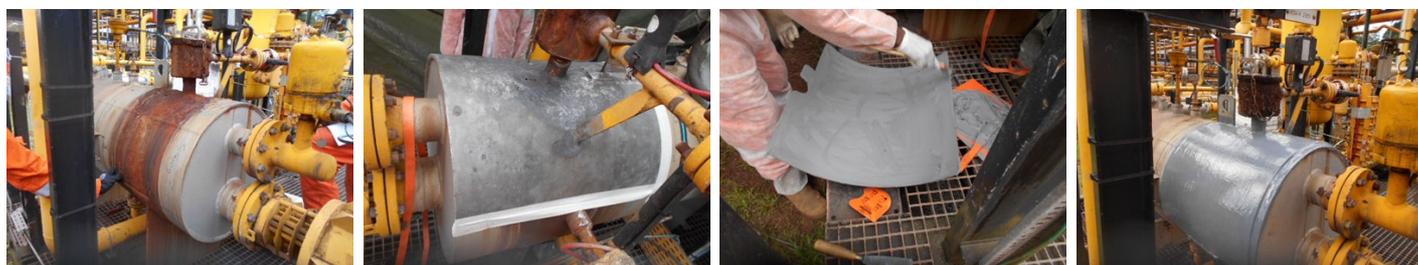
Photograph Descriptions

Corrosion Under Insulation had caused pinholes in the tank wall. An in-situ was required to ensure minimal disruption to production.

- * Tank suffering from corrosion under insulation ,
- * After surface preparation ,
- * Plate cut and ready to be bonded with Belzona 1111 ,
- * Finished application after coating with Belzona 1321 ,

Application was carried out in accordance with Belzona Know-How System Leaflet TCC-1. After surface preparation had been carried out, a custom-made plate was bonded using Belzona 1111. The plate was cut to fit the nozzle and brackets on the tank and was grit blasted prior to going offshore. As an additional protection, Belzona 1321 was applied on top of the plate to prevent future issues with corrosion under insulation.

The temperature at the time of the application was dropped down to 40°C. The work was completed over 1 shift which was greatly appreciated by the offshore operator and ensured production could continue with minimal disruption.
