# BELZONA GRIP SYSTEM OUTSTRIPS THE COMPETITION

**Industry:** General Industry  
**Application:** FPA-Floor Problem Areas  
**Substrate:** Concrete  
**Products:** \* Belzona 4411 (Granogrip) ,  
 \* Belzona 9231 (Surefoot Aggregate) ,

**Customer Location:** Pharmaceutical Company, UK  
**Application Date:** 2005 - 2011

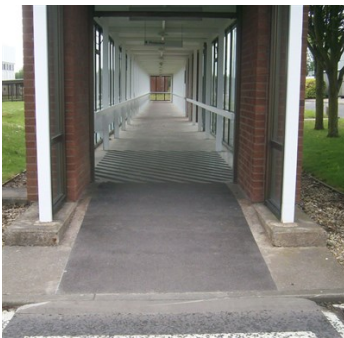
- \* Original application revisited after 6 years ,
- \* Typical condition of tapes after 3 months ,
- \* Belzona application extended in 2011 ,

In 2005 the client had used Belzona 4411 on a series of external ramps to avoid slip incidents. As they later found adjacent areas that were undercover were also hazardous, they applied slip resistant adhesive tapes from a leading manufacturer. Unfortunately, the tapes would repeatedly fail and the loss of adhesion at the edges meant that they became trip hazards. These tapes would have to be reapplied every 12-18 months which was costly and disruptive. In the same 6-year period the Belzona materials had suffered only very minor damage, and so the client decided to extend the original application onto the undercover areas.
