# BELZONA GRIP SYSTEM OUTSTRIPS THE COMPETITION

**Customer Location:** Pharmaceutical Company, UK

**Application:** FPA-Floor Problem Areas

Grip Coating for Ramps and Corridors.

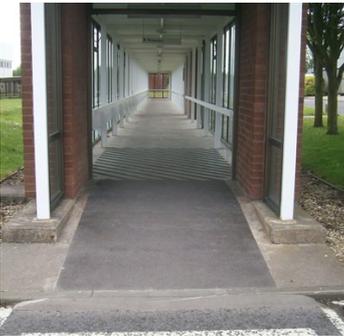
- \* Original application revisited after 6 years ,
- \* Typical condition of tapes after 3 months ,
- \* Belzona application extended in 2011 ,

Belzona 4411 is solvent free and applied in a single coat, making the application very fast and ideal for sensitive areas. There are also a choice of colours and aggregates that can even survive heavy vehicle traffic. In 2016 the original areas were revisited and Belzona system continued to offer superb performance after 11 years continuous service.

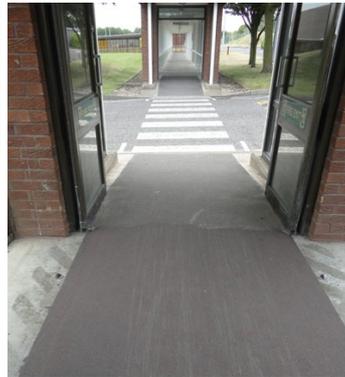
In 2005 the client had used Belzona 4411 on a series of external ramps to avoid slip incidents. As they later found adjacent areas that were undercover were also hazardous, they applied slip resistant adhesive tapes from a leading manufacturer. Unfortunately, the tapes would repeatedly fail and the loss of adhesion at the edges meant that they became trip hazards. These tapes would have to be reapplied every 12-18 months which was costly and disruptive. In the same 6-year period the Belzona materials had suffered only very minor damage, and so the client decided to extend the original application onto the undercover areas.
