# BELZONA PROTECTS BOX GUTTERS

Industry: Buildings & Structures  
Application: RPA-Roof Problem Areas  
Substrate: Plastic coated steel.  
Products: \* Belzona 3111 (Flexible Membrane) ,

Customer Location: Corporate Office, Teesside, UK  
Application Date: 2013

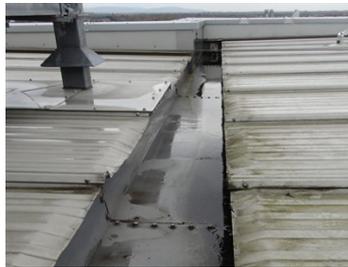
The client was about to take possession of a newly constructed office block. However, the gutters were leaking at multiple points around the building and so they were refusing to take ownership until the roof was watertight. It was thought that the joints and drain points were at fault. The main contractor had tried to seal these with a bituminous coating, which was ineffective and so needed to be removed. Belzona were approached for a liquid applied solution that could be backed by a warranty.

- \* Building front aspect ,
- \* Typical gutter on initial inspection ,
- \* Application of Belzona 3111 underway ,
- \* Application completed ,

With so many people already working in the building, the water based Belzona 3111 system was ideal. A seamless flexible

membrane was applied along the full length of all of the roof gutters and up the joints of the parapet wall with a total length over 320 metres. Once completed, the contractor issued a warranty so that the client finally had the confidence to take ownership of the building.
