BELZONA PROTECTS BOX GUTTERS

ID: 6111

Industry: Buildings & Structures
Application: RPA-Roof Problem Areas
Substrate: Plastic coated steel.
Products: * Belzona 3111 (Flexible Membrane) ,

Customer Location: Corporate Office, Teesside, UK
Application Date: 2013

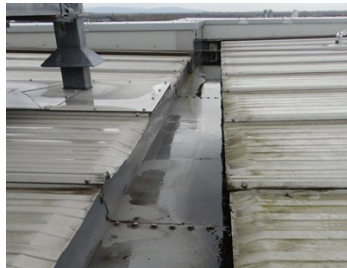
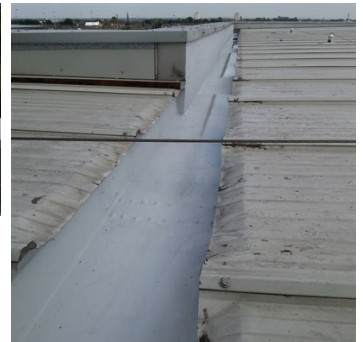
Photograph Descriptions

The client was about to take possession of a newly constructed office block. However, the gutters were leaking at multiple points around the building and so they were refusing to take ownership until the roof was watertight. It was thought that the joints and drain points were at fault. The main contractor had tried to seal these with a bituminous coating, which was ineffective and so needed to be removed. Belzona were approached for a liquid applied solution that could be backed by a warranty.

- * Building front aspect ,
- * Typical gutter on initial inspection ,
- * Application of Belzona 3111 underway ,
- * Application completed ,

Application was carried out in accordance with Belzona Know-How System Leaflets RPA-6 and RPA-8.

With so many people already working in the building, the water based Belzona 3111 system was ideal. A seamless flexible

membrane was applied along the full length of all of the roof gutters and up the joints of the parapet wall with a total length over 320 metres. Once completed, the contractor issued a warranty so that the client finally had the confidence to take ownership of the building.
