BELZONA SEALS SWITCH ROOM ROOF PENETRATIONS

ID: 6112

Customer Location: Power Station, Teesside, UK
Application Date: 2009

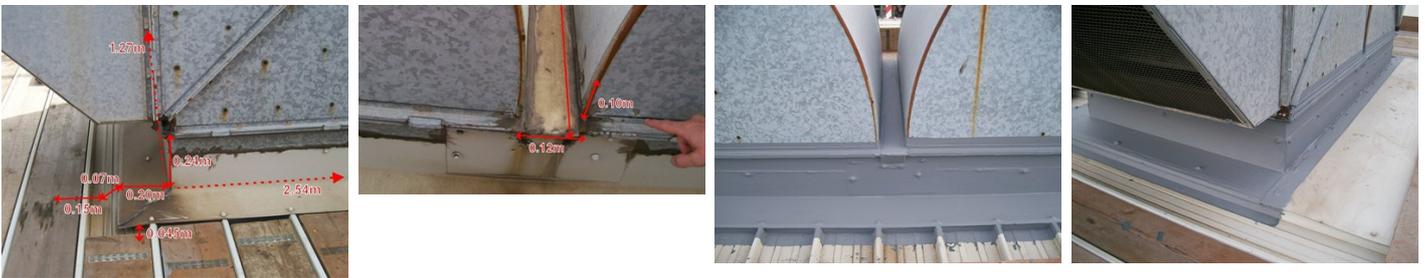
A series of vents and AC units had been positioned on roofs over the switch rooms. Cladding panels and sealant had been used in attempts to weatherproof the penetrations but this had proved ineffective. In addition, some of the fabrication joints for the vents were also failing, which allowed even more water in. After an incident which had forced sections of the power plant to shut down, Belzona were approached for a solution that could rapidly be installed to seal the complicated details and roof profiles.

- * Switch room vent, cladding detail ,
- * Failed fabrication seam ,
- * Seams and cladding sealed with Belzona 3111 ,
- * Completed application ,

Applications were carried out in accordance with Belzona Know-How System Leaflets RPA-01, RPA-6, and RPA-8, to address the different situations.

be delivered in a single day. A series of vents and AC units were sealed quickly to prevent further water damage and disruption to the facilities. This localised application consumed minimal materials and proved very cost effective.
