BELZONA REBUILDS THE WALLS OF A SECONDARY CONTAINMENT AREA

ID: 6115

Customer Location: Cement Plant, Oregon, USA
Application Date: September 2015

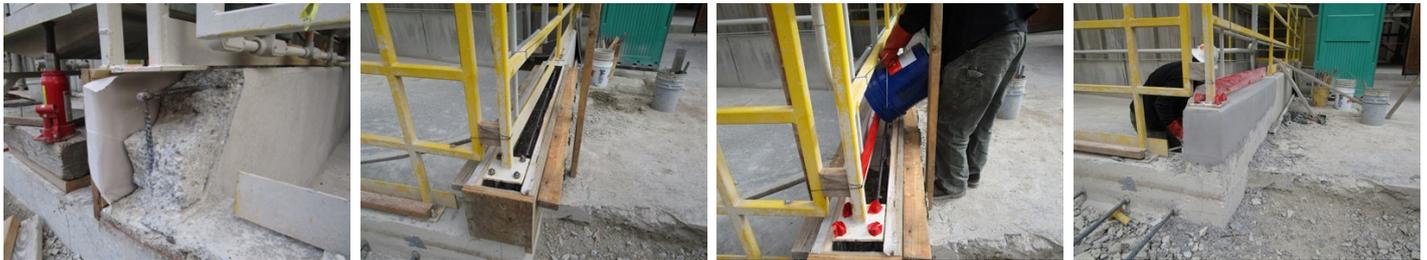
Photograph Descriptions

Severe cracks and damage in the walls of the ammonia secondary containment due to design issues.

- * Showing damage to the walls ,
- * Forming boards used for the application of Belzona 4154 ,
- * Pouring of Belzona 4154 ,
- * Completed application showing Belzona 4111 as a top layer ,

The damage at the SE corner required cutting out a section of the walls in one area and a simple removal of a small section at the SW corner. A grinder was used to remove oxidation from rebar. Belzona 4911 was applied to the steel rebar and concrete. Form boards were attached to the concrete to create a frame before pouring Belzona 4154. Once cured, the form boards were removed. A grinder was used to remove the gloss off of Belzona 4154, then the surface was wetted with Belzona 4911 to prepare it for the application of Belzona 4111 as a finishing layer.
