# BELZONA REJUVINATES AGED ASPHALT ROOF

ID: 6117

Customer Location: Power Station, Teesside, UK  
Application Date: 2016

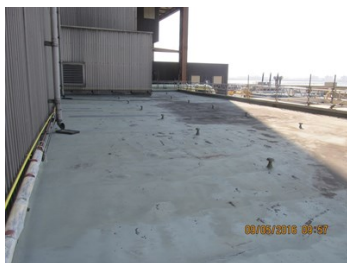
*This aged asphalt roof was cracked in many places and there were several large ponding areas where water would not fall to drains. A much larger pitched roof above it also drained directly onto the asphalt, resulting the roof having to accommodate about six times more water than it was designed for. These problems had led to several leaks being identified in the plant rooms beneath and essential equipment was at risk of being ruined. Environmental and safety considerations mean the client preferred a water based system.*

- \* Roof with ponding areas on right ,
- \* Application of Belzona 3111 underway ,
- \* Protection completed ,
