SWIMMING POOL FILTERS SEALED WITH BELZONA

Industry: *General Industry*
Application: *TCC-Tanks and Chemical Containment Areas*
Substrate: *Stainless steel*
Products: ** Belzona 1212 ,
* Belzona 5811DW2 (DW Immersion Grade) ,*

Customer Location: *Engineering Co, Slovenia*
Application Date: *May 2016*

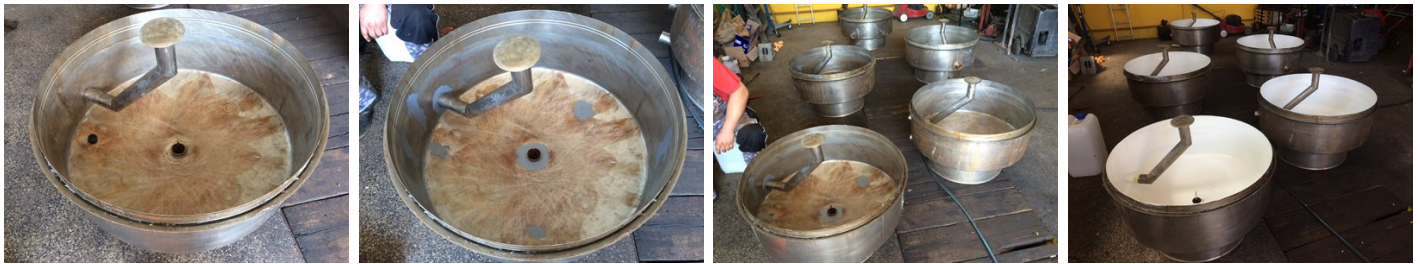
Photograph Descriptions

Filters were leaking due to defective welds

- * One of the filter drums ,
- * Belzona 1212 application to welds ,
- * Belzona 5811DW2 application ,
- * Completed application ,

Application was carried out in accordance with Belzona Know-How System Leaflets TCC-1 and TCC-4. Belzona 1212 was used to seal and smooth welds before applying Belzona 5811DW2 to provide overall corrosion protection.

Time to get back in service was of most importance. The Belzona system provided fast and long term repair and protection to old filter drums.
