BELZONA CREATES NON-SLIP SAFETY SURFACE IN FISH MARKET

ID: 6148

Application: FPA-Floor Problem Areas

Customer Location: Fish market, Croatia

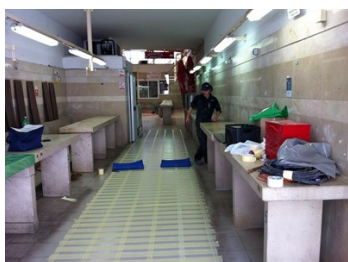
* 1. Situation in the fish market, positioning of masking tape 2. Surface preparation. 3. Application of Belzona 5231 with additional aggregate incorporated. 4. Application completed - situation after washing the floor ,

The application was carried out in accordance with Belzona Know-How System Leaflet FPA-8. Additional Belzona 9211 aggregate was incorporated into the Belzona 5231 for better anti-slip protection.
