# BELZONA SEALS NEW PIPES IN HOTEL WATER RESERVOIR

ID: 6168

Customer Location: *Hotel, Israel*  
Application Date: *2013*

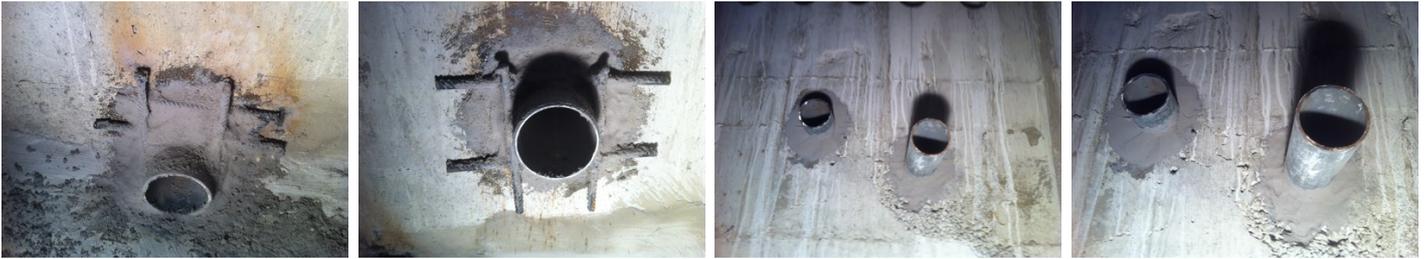
*New pipes drilled into water reservoir needed to be anchored and sealed to the tank wall.*

- \* 1 & 2. Internal application to secure new pipes ,
- \* 3 & 4 External fixing of pipes ,

Application carried out in accordance with Belzona Know How System Leaflets FPA-5

The customer was looking for reliable solution since on previous experience leaks had occurred around the pipes. Belzona 4111 provides high bond strength without shrinking enabling a secure leak free installation.
