BELZONA SEALS HIGH RISE ROOF

ID: 6187

Application: *RPA-Roof Problem Areas*

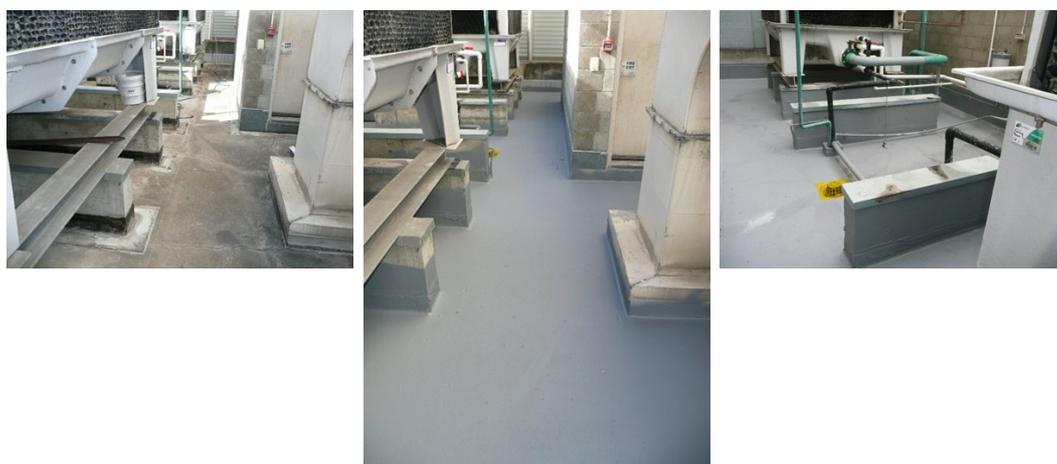
Water was leaking into the offices below and required a waterproof solution.

* 1. The roof prior to application 2. The finished coating 3. Alternate view of the sealed area ,

Concrete deck around cooling tower on the roof of a high rise building.

The application was carried out in accordance with Belzona System Leaflet RPA-1. The concrete was power washed to remove all dirt and detritus. Cracks that were revealed following the cleaning were then filled and sealed using Belzona 4151. The entire roof area was then coated with a fully reinforced Belzona 3111 system.
