BELZONA WATERPROOFS CORPORATE HEADQUARTERS

ID: 6188

Application: RPA-Roof Problem Areas

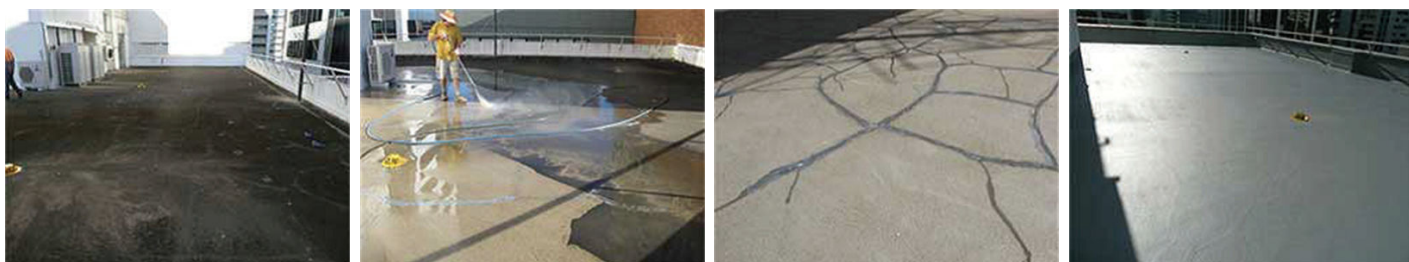
Photograph Descriptions

Improper sealing of the roof structure of the high rise building was allowing water to leak into the offices below.

* 1. The existing roof 2. Power washing in progress 3. Cracks exposed and sealed with Belzona 4151 4. The finished application after application of the Belzona 3111 system ,

Application was carried out in accordance with Belzona System Leaflet RPA-1. The roof of the building was cleaned using a high pressure water wash and detergent. Once Cleaned, cracks were filled and sealed using Belzona 4151. The entire roof was then sealed using the fully reinforced Belzona 3111 system to prevent any future water ingress.
