# BELZONA RESTORES FRESH WATER COOLERS

**Industry:** *Marine*  
**Application:** *HEX-Heat Exchangers*  
**Substrate:** *Aluminium*  
**Products:** *\* Belzona® 5891 (HT Immersion Grade) ,*  
*\* Belzona® 1111 (Super Metal) ,*

**Customer Location:** *Italian Navy*  
**Application Date:** *September 2005*

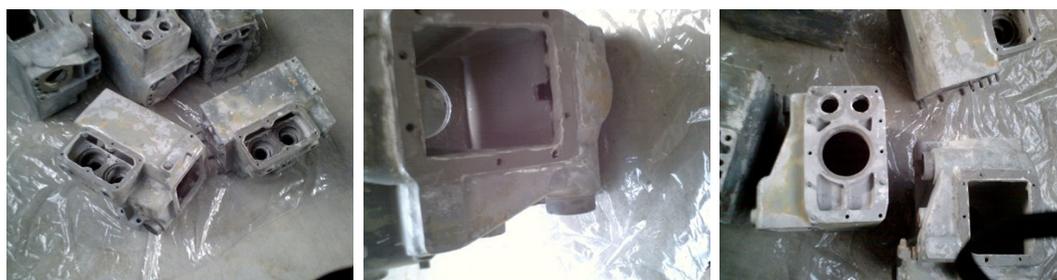
*Corrosion-erosion of inside vane, outside flanges and stud threads.*

- \* Upper side of flange and valve seat ,
- \* Inside vane coated with Belzona® 5891 ,
- \* View of coupling flanges ,

Application was carried out in accordance with Belzona Know-How System Leaflets HEX-2 and HEX-3.
