BELZONA RECASTS NEW PERIMETER EXPANSION JOINTS FOR OUTDOOR POOL

ID: 6288

Customer Location: Coquitlam, BC

Application: FPA-Floor Problem Areas

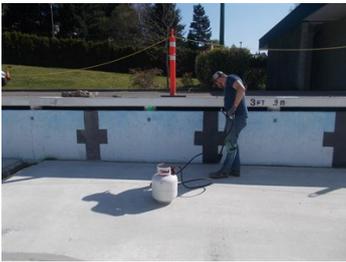
- * 1. Joints needed to be dried out prior to casting ,
- * 2. Joints masked off for a neat and tidy finish ,
- * 3. Injection of Belzona 2221 into expansion joint slot ,
- * 4. Completed joint. ,
