BELZONA REPAIRS FATTY ACIDS CONTAINMENT AREA

ID: 6322

Application: *TCC-Tanks and Chemical Containment Areas*

Secondary containment area where fatty acids were stored

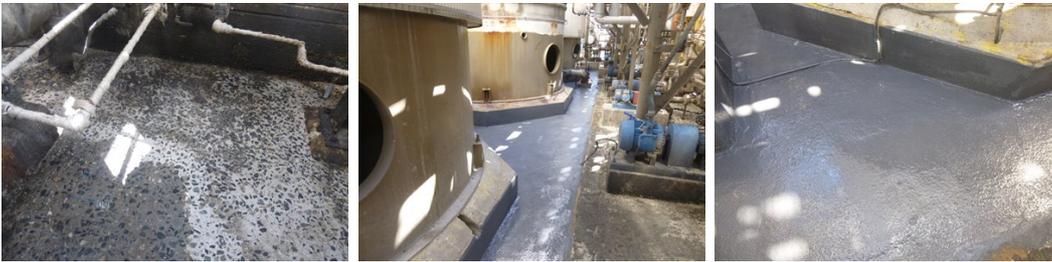
Photograph Descriptions

Concrete surfaces were severely corroded and eroded from leaking equipment.

- * 1. Severely corroded and eroded concrete resulting from leaking equipment. ,
- * 2. First part of the repair in contrast to the original condition. Belzona 4154 mixed with sand plus 2 coats of Belzona 5811. Draining rebuilt to eliminate ponding. ,
- * 3. Closer look at the repair. ,

Old surfaces were pressure washed and any loose material was removed. The eroded concrete surfaces were resurfaced using Belzona 4154 mixed with sand. The surfaces were built up to original spec (up to 1.5 inches in some areas) and new gradients were created to ensure correct drainage. Belzona 4181 was used to repair the concrete directly under the steam lines. Two coats of Belzona 5811 were applied on the rebuilt surfaces. The application area was approximately 800 square feet.
