BELZONA REBUILDS CONDUIT GAP

ID: 6325

Customer Location: Battery Manufacturing Plant, NC, USA
Application Date: June 2016

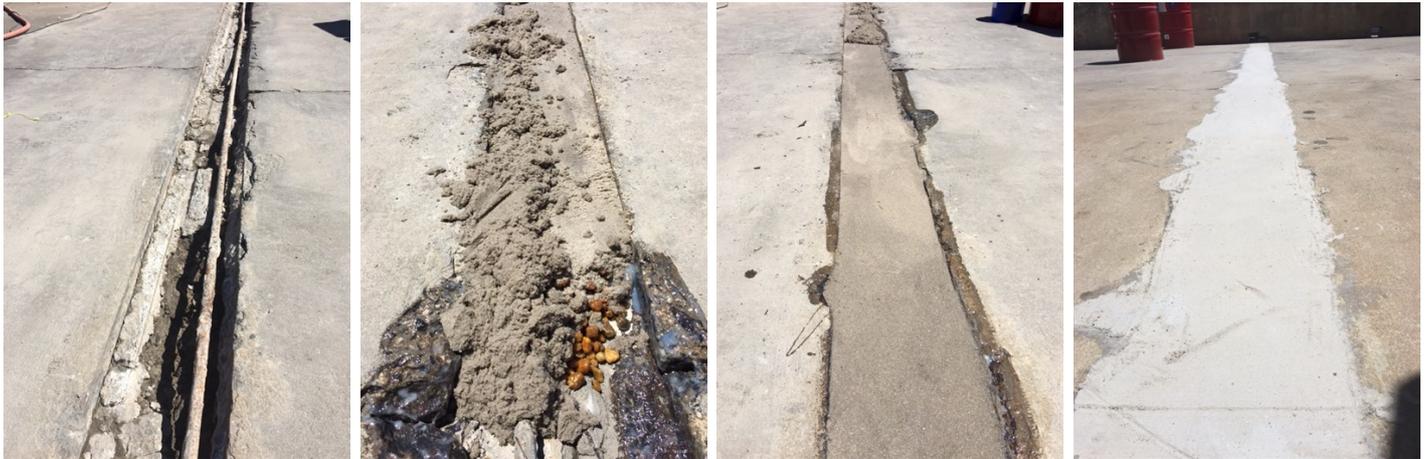
Photograph Descriptions

Conduit was buried in concrete. The concrete started failing.

- * 1. Empty conduit gap. ,
- * 2. Taking up volume with Belzona 4154 with river rock followed by Belzona 4154 with sand on top. ,
- * 3. After spreading the Belzona 4154 with sand. ,
- * 4. Top coated with Belzona 4111. ,

All the concrete was cleaned out and where it was not already rough, grinders were used to roughen the substrate. Belzona 4154 was mixed with clean river rock to bulkfill the conduit gap. Once the conduit gap was filled up, Belzona 4154 was mixed with sand and spread out. The bulkfill was top coated with Belzona 4111 for added strength and blend. The application was carried out in accordance with Belzona Know-How System Leaflet FPA-12.
