GRIPPING BELZONA SOLUTION FOR THE MILLENNIUM BRIDGE

Customer Location: Local Authority, Gateshead, UK

Application Date: July 2012

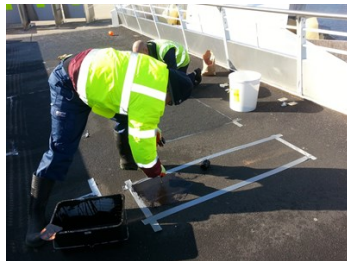
The local council required a number of patch repairs to the bridge due to wear on the original system causing slip hazards especially in the damp winter months.

- * 1. View of Millennium Bridge ,
- * 2. Application of Belzona 5811 ,
- * 3. Completed patch repairs ,
- * 4. Application revisited in 2016 ,

The application was carried out in accordance with Belzona Know-How System Leaflet FPA-8. The worn areas were masked off, cleaned and dried prior to application of the Belzona system. Two coats of Belzona 5811 were applied then blinded out with Belzona 9231 Aggregate and tamped down with a piece of timber. Once the product had cured all loose aggregate was removed to reveal the desired non-slip surface.

The 126 meter bridge stretches across the River Tyne and since its opening in 2001 has seen significant footfall. The Belzona repair solution, first applied in 2012 was revisited in 2016 and showed no signs of deterioration. Areas around the repair have worn away but the Belzona high performance system is still sound.
