BELZONA REPAIRS DOME ROOF

ID: 6336

Customer Location: Mosque, Woking, UK
Application Date: September 2016

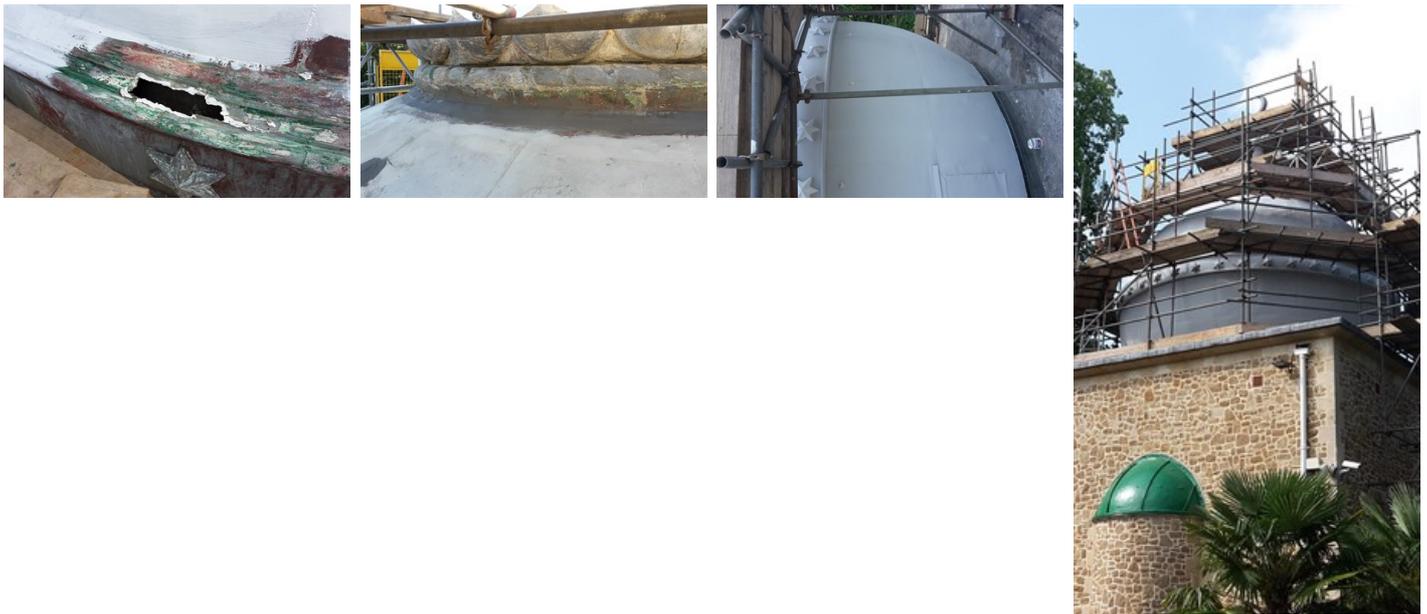
Photograph Descriptions

The dome was showing signs of ageing and there were a large number of holes around its circumference.

* 1, Extent of the damage 2, Damaged zinc dome rebuilt with Belzona 1121 3, Belzona 3111 applied 4, Completed application prior to the removal of the scaffolding ,

Belzona 1121 (Super XL-Metal) was used to rebuild any through-wall defects on the dome incorporating wire mesh to rebuild and reinforce the damaged areas. Once cured, the areas were re-profiled to the original state. Once damaged areas had been repaired Belzona 3111 system was applied in accordance with Belzona Know-How System Leaflet RPA-7 to provide long-term roof protection and waterproofing.
