# BELZONA PROVIDES ABRASION RESISTANT PROTECTION FOR SCREW CONVEYOR

ID: 6349

Industry: *Water / Wastewater*  
Application: *SHM-Solids Handling Machinery*

Customer Location: *Waste water treatment plant, Romania*  
Application Date: *May 2013*

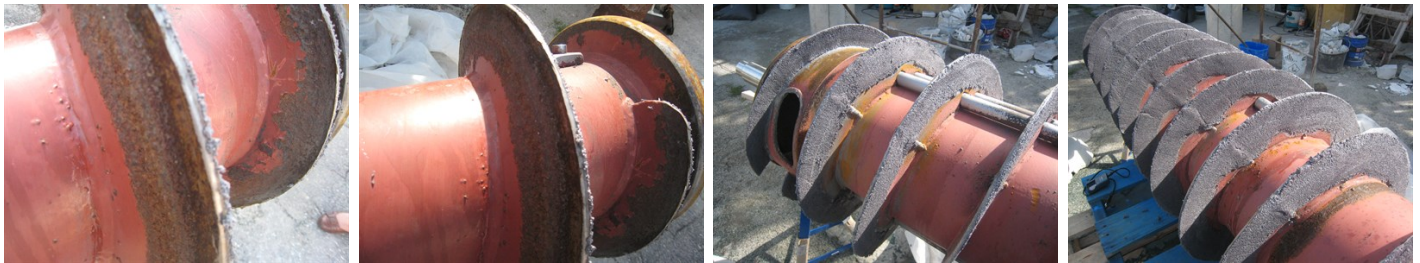
## Photograph Descriptions

*As part of its operation in a treatment plant's slurry clarifier, the screw conveyor was transporting dehydrated slurries. The hard particles in the slurry were causing abrasion of the conveyor blades.*

\* 1. Screw conveyor affected by erosion corrosion 2. Metal loss on the blades 3. Belzona 1812 applied 4. Equipment life extended with Belzona protection ,

The screw conveyor at a water treatment plant was suffering from significant metal loss.

Application was carried out in accordance with Belzona System Leaflet SHM-14. After gritblasting Belzona 1812 was applied to the blades to provide abrasion resistant protection.

Belzona 1812 (Ceramic Carbide FP) offers resistance to abrasive wear, significantly extending the life of the screw conveyor.
