BELZONA REBUILDS SECONDARY CHEMICAL CONTAINMENT

ID: 6353

Customer Location: *Eastover, SC, USA*
Application Date: *August 2016*

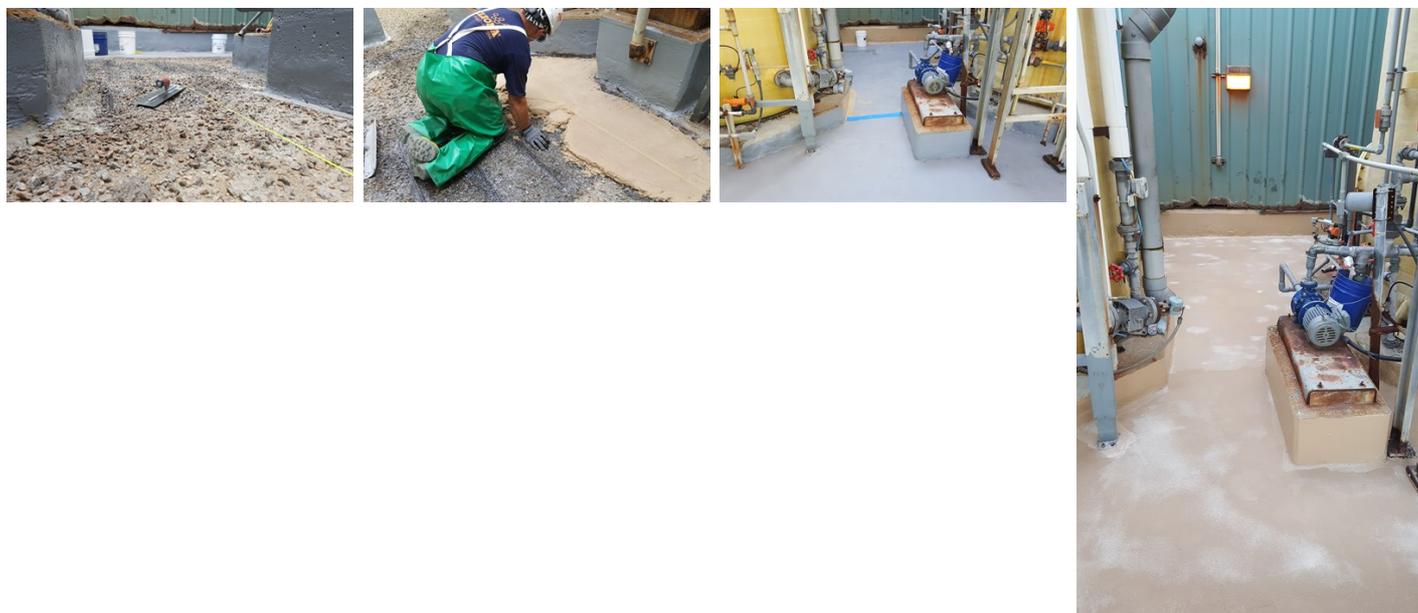
Photograph Descriptions

Repeated contact with caustic and hydrochloric acid over a period of years had caused serious damage to the concrete floor, tank and pump support bases.

- * 1. Damaged concrete showing depth below grade. ,
- * 2. Belzona 4154 being used to fill deeply eroded area. ,
- * 3. Final grade with Belzona 4131 (Magma-Screed). ,
- * 4. Final coat with Belzona 5811 and broadcast aggregate. ,

Badly damaged concrete in a caustic and hydrochloric acid secondary containment area at a chemical plant. Both caustic and hydrochloric acid are at 10% concentration and at ambient temperature.

The application was carried out in accordance with Belzona System Leaflets TCC-9 and TCC-15. Damaged and loose concrete was removed and the entire area was high pressure water washed. PH testing was carried out and the area verified neutral after washing. When dry the eroded vertical surfaces of the tank and pump support bases were rebuilt with Belzona 4141 (Magma-Build). The deeply eroded areas of the concrete floor were filled to within approximately 1/4" of the final grade using Belzona 4154 (Bulkfill Resin) and sand. The final grade required for proper drainage was achieved using Belzona 4131 (Magma-Screed). The entire area was protected with Belzona 5811 with a light broadcast coat of aggregate for slip-resistance.
