# BELZONA WEATHERPROOF PROTECTION FOR INSPECTION BOXES

ID: 6362

Customer Location: North Wales, UK  
Application Date: April, 2016

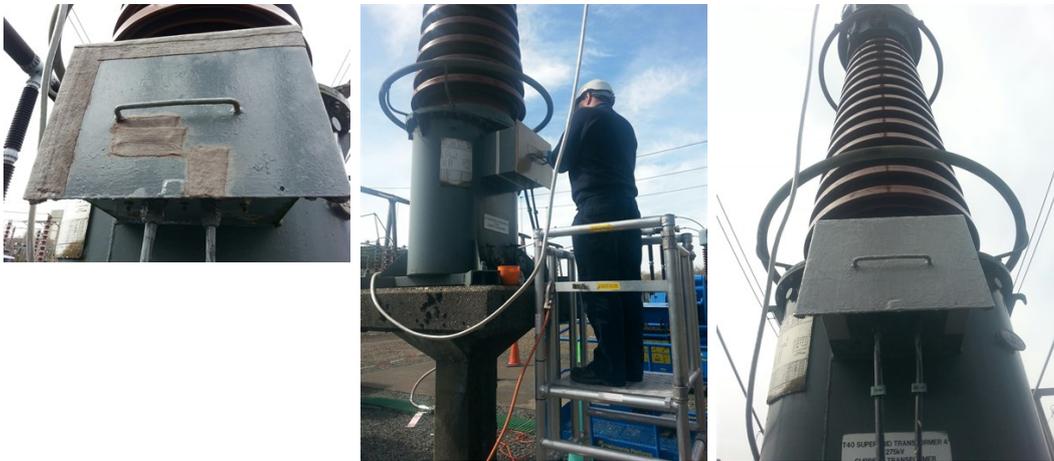
Previous repairs on the boxes had been unsuccessful and close inspection revealed concealed through-wall defects as well as general corrosion damage. The customer wanted a solution that would waterproof the boxes, but could be removed when the switches inside were due for inspection.

\* 1. Corroded inspection box 2. Belzona application in action 3. Completed application 4. System revisited after 8 months ,

Corroded inspection box covers at a National Grid site.

The application was carried out in accordance with Belzona Know-How System Leaflets TCC-1 and GSS-11. Holes were repaired by bonding on small metal plates and other areas of corrosion were rebuilt with Belzona 1111 to allow the cover plate to fit correctly. Belzona 3411 system was then applied to seal the cover plate to provide a water-tight seal.

The customer was very happy with the end result. The Belzona repairs ensured a long term solution and the use of the Belzona 3411 made access for inspection to the switches simple. The inspection hatches were revisited 8 months later and the Belzona

solution was found to be in perfect condition.
