# AN OLD STEEL TANK PUT BACK TO SERVICE WITH BELZONA

ID: 6380

Customer Location: Gulf of Mexico, USA  
Application Date: August 2016

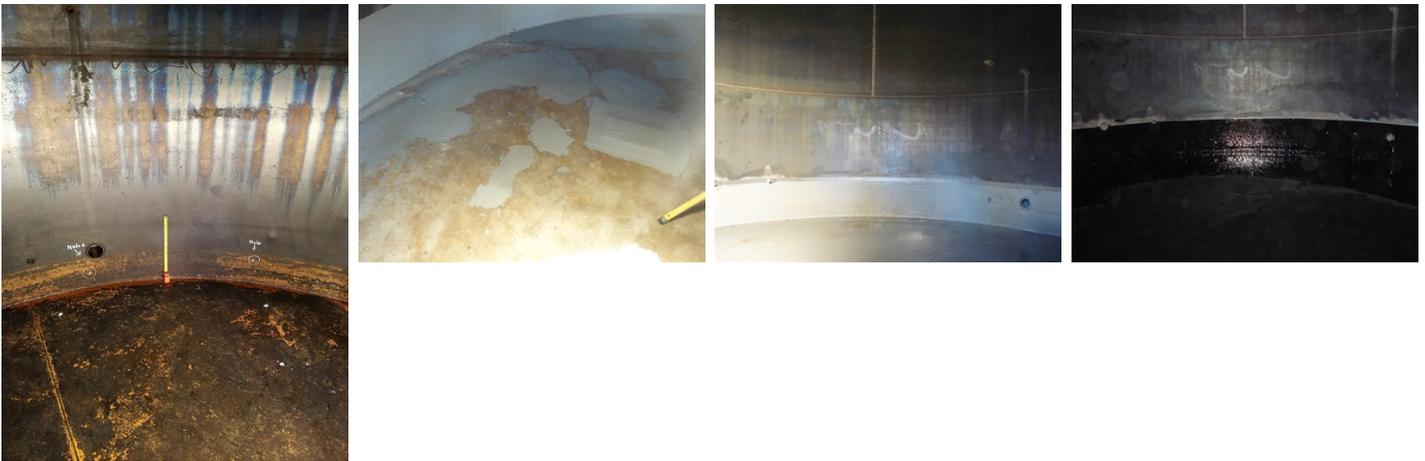
Hundreds of holes in the floor and 8" up walls of the interior of this bulk storage tank. Large holes were visible and straightforward to repair. Small holes and metal porosity plague the entire surface.

- \* 1. Hundreds of holes in tank floor and walls. ,
- \* 2. Process of Belzona 1121 composite repair and cold plate bonding on floor. ,
- \* 3. First coat Belzona 5811 Grey ,
- \* 4. Second coat Belzona 5811 Black ,

Belzona 1121 was used to cold plate bond steel over large holes and incorporated into Belzona 9341 cloth for smaller ones. Two coats of Belzona 5811 was used over all surfaces to seal micro porosity.

The two alternatives to the Belzona solution were both costly and dangerous on the platform. Total replacement of the bottom and sides would take months of work and lose the ability of oil storage. Overlay welding and grinding was dangerous and could not guarantee the smallest holes would be sealed.
