# BELZONA HELPS FIRE PUMP PERFORM AGAIN

ID: 6403

Bronze Fire pump impeller on a US Navy Ship

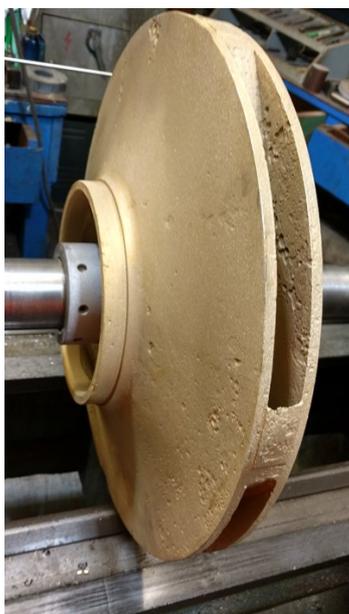
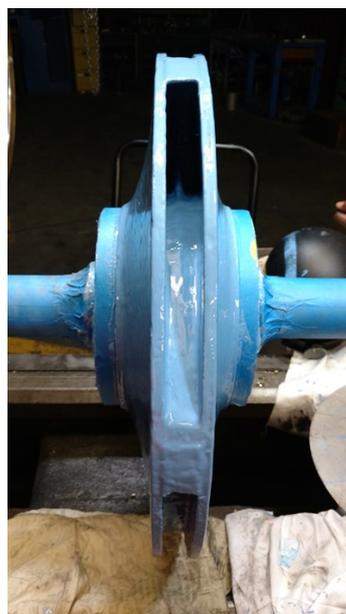
*Impeller had suffered heavy cavitation and erosion due to contact with salt water.*

- \* 1. Bronze pump impeller grit blasted and showing damage. ,
- \* 2. Eroded areas rebuilt with Belzona 1111 ,
- \* 3. Impeller coated with Belzona 1341 ,
- \* 4. Belzona 1131 applied to wear ring area ,

The application was carried out in accordance with a modified version of Belzona System Leaflet CEP-3. Cavitated and eroded areas were rebuilt with Belzona 1111. The impeller was then coated with two coats of Belzona 1341 by brush; grey base coat, followed

by a blue top coat. Critical wear ring area was rebuilt with Belzona 1131.
