BELZONA POSITIVE GRIP SYSTEM PROVIDES SAFETY TO WORKERS

ID: 6405

Industry: *General Industry*
Application: *FPA-Floor Problem Areas*
Substrate: *Carbon Steel*
Products: ** Belzona 5811 (Immersion Grade) Belzona 9211 (Supergrip Aggregate) ,*

Customer Location: *Nashville Tennessee Manufacturer*
Application Date: *September 2016*

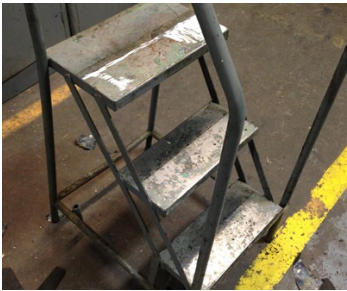
* 1. Steps prepared for application 2. Application of Belzona 5811 in progress 3. Application of Belzona 5811 and 9211 completed 4. Application revisited two months later, already outperforming the non-slip tape ,

Application was carried out using Belzona Know-How System Leaflet FPA-8. Steps were cleaned and roughened with an angle grinder. Edges were taped off to create clean lines. First, Belzona 5811 was applied at 20 mils thickness, then Belzona 9211 was added to the point of rejection.
