# BELZONA SEPARATES DISSIMILAR METAL PIPES

ID: 641

Industry: Oil & Gas

Customer Location: Offshore platform, UK

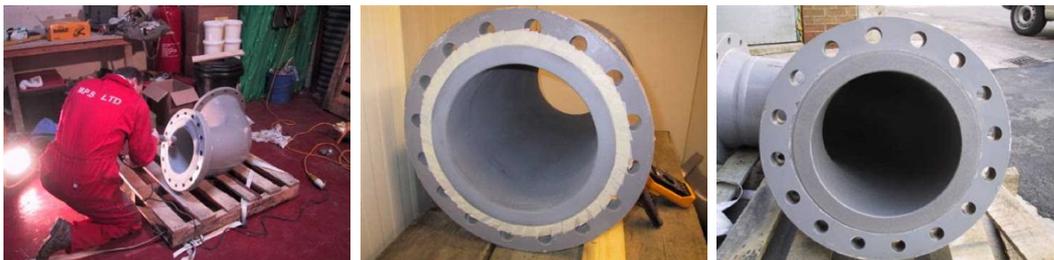
Galvanic corrosion between dissimilar pipe sections.

- \* Surface Preparation ,
- \* Pipe masked up ,
- \* Finished Application ,

Pipe linings and flanges.

Application was carried out in accordance with Belzona Know-How System Leaflet VPF-2.

Belzona's electrical isolating properties form a barrier to the electrolytic cell set up by the dissimilar metal thus stopping galvanic corrosion. The previous vulcanized rubber coating had failed in less than 6 months. These repairs were still in service four years later.
