# BELZONA RESTORES AND PROTECTS GATE VALVE

**Industry:** Mining & Quarrying  
**Application:** CEP-Centrifugal Pumps  
**Substrate:** Carbon Steel  
**Products:** \* Belzona 1311 (Ceramic R-Metal) ,  
\* Belzona 1341 (Supermetalglide) ,

**Customer Location:** Copper Mining Company, Bulgaria  
**Application Date:** April, 2015

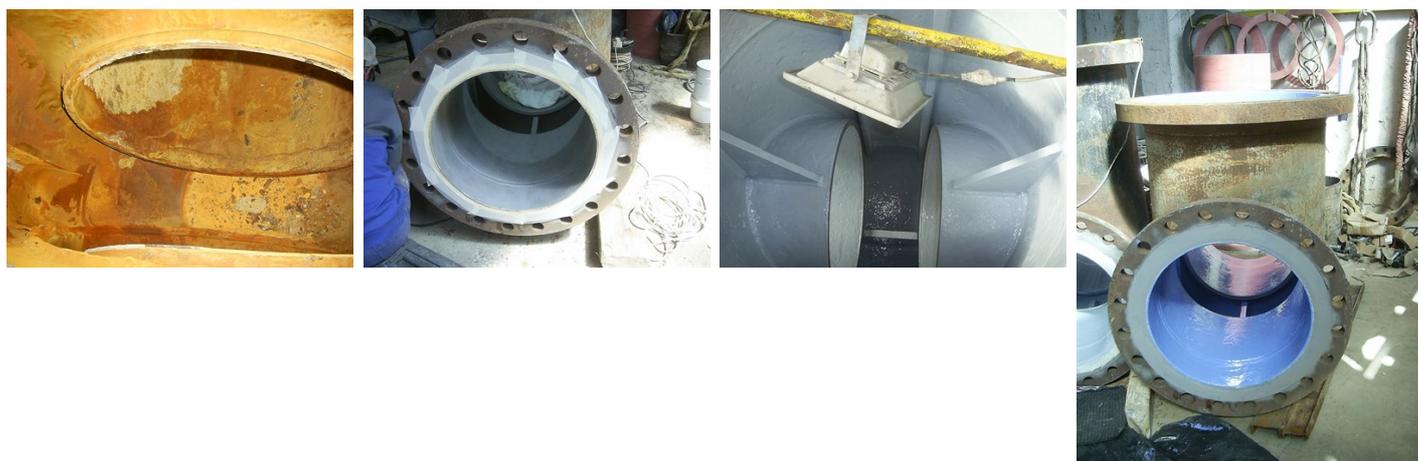
Strong corrosion and erosion on the inner surfaces of all 3 gate valves.

- \* 1. General view of the valve before repair ,
- \* 2. After blasting and flange masking ,
- \* 3. 1st coat of Supermetalglide applied ,
- \* 4. Final view of the completed application ,

The application was carried out according to Belzona Know-How System Leaflet CEP-1 and CEP-3. The internal welds, pitting and damage were filled with Belzona 1311 then two coats of Belzona 1341 were applied.
