# FORMATION OF LOW PROFILE OIL CONTAINMENT TRAPS WITH BELZONA

ID: 660

Customer Location: Mobile machinery manufacturer, Wales  
Application Date: Ongoing since 1995

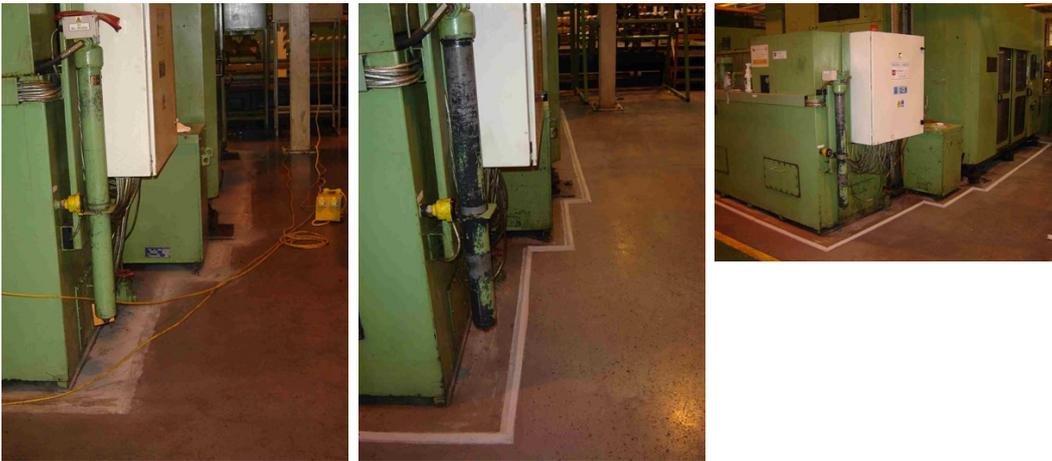
## Photograph Descriptions

The problem is leaking oil (or chemicals) from machinery which seeps/spills/runs across the floor and into pedestrian walkways. This causes problems from both an environmental standpoint and also safety as oily floors equals slip hazards(multiplied by its proximity to machinery).

- \* Agreed area around machinery prepared ,
- \* Pipe removed Belzona® 4111 trap formed ,
- \* Finished job neat and effective ,

The area where the containment trap is to be created is carefully chosen so as not to create a potential trip hazard. The application is carried out in accordance with a modified version of Belzona Know-How System Leaflet TCC-9. Two-inch plastic pipe sections, cut in half length wise are used to form the Belzona® 4111 containment dam.
