BELZONA ELASTOMERS USED FOR SWIMMING POOL EXPANSION JOINTS

ID: 661

Customer Location: *Langley, BC Canada*
Application Date: *October 2005*

Expansion joints in Olympic size swimming pool

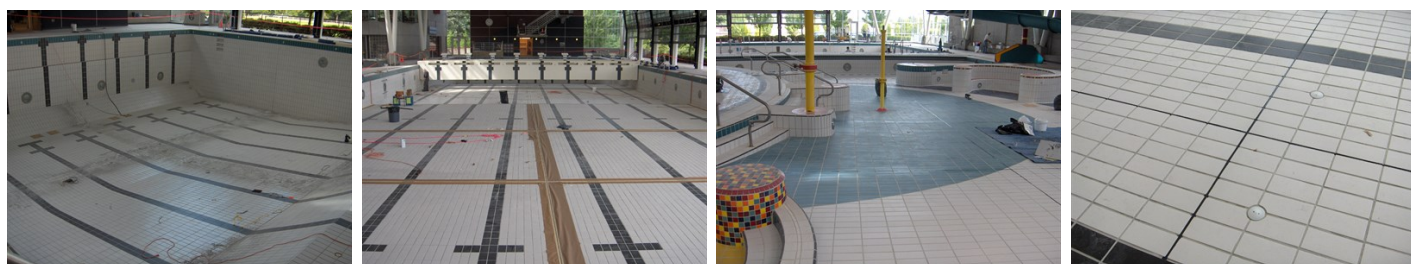
Photograph Descriptions

Original expansion joint material was no longer effective

- * Preparation of expansion joints underway ,
- * Grinding completed and masking of joints underway ,
- * View of completed recreation section of the pool ,
- * Close up view of completed joint ,

Application was carried out in accordance with Belzona Know-How System Leaflet FPA-6

This pool required the sealing of approximately 3000 linear feet of jointing. Belzona Elastomers have built a history of longevity and durability in these types of applications spanning 8 years. This is now the 14th such application in British Columbia, Canada
