BELZONA PROTECTS SCREW CONVEYORS FROM EROSION

Customer Location: Solids Handling Machinery
Manufacturer, Richmond, BC

Application: SHM-Solids Handling Machinery

Protection of screw conveyors

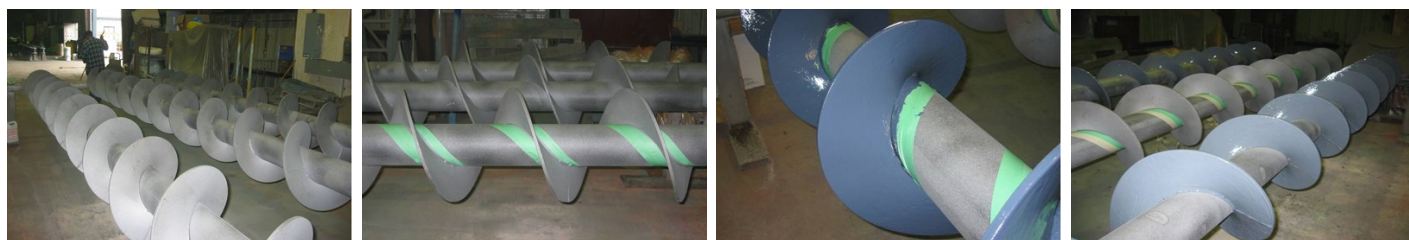
Photograph Descriptions

- * View of augers after blasting. ,
- * First auger masked off ready for application of first coat of Belzona® 1321(Blue). ,
- * Application of first coat in progress. ,
- * Application of second coat of Belzona® 1321 (Grey) completed with second auger masked off awaiting application. ,

Application carried out in accordance with Belzona Know-How System Leaflet SHM-14.
