BELZONA PROTECTS 10,000 SQUARE FEET OF FLOORING

Industry: Chemical & Petrochemical
Application: TCC-Tanks and Chemical Containment Areas
Substrate: Concrete
Products: * Belzona® 5811 (Immersion Grade) ,
* Belzona® 2131 (D&A Fluid Elastomer) ,

Customer Location: Chemical Plant in Alabama
Application Date: December 1996

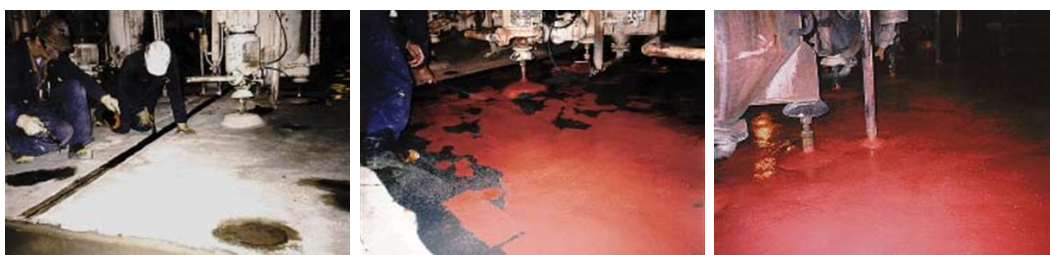
Photograph Descriptions

The chemical plant needed to prevent mercury from entering the ground through the concrete containment. The situation was aggravated by 50% KOH (potassium hydroxide) that was attacking the concrete and expansion joint sealant.

- * Bridging over expansion joint in accordance with modified Belzona application procedure TCC-12 with Belzona® 2131. ,
- * First coat of Belzona® 5811 applied with Belzona® 9221 (Surefoot Aggregate White) broadcast for non-skid safety system. Application of second coat Belzona® 5811 (tinted red) in progress. ,
- * The completed application, floor and ground protected from chemical degradation and contamination. ,

The application was carried out in accordance with Belzona Know-How Leaflets TCC-12 and TCC-15.
