# BELZONA PROTECTION TO FOAM GLASS INSULATION ON TANK

**Industry:** Chemical & Petrochemical  
**Application:** TCC-Tanks and Chemical Containment Areas  
**Substrate:** Styrofoam insulation  
**Products:** \* Belzona® 3211 (Lagseal Membrane) ,  
\* Belzona® 9321 (Lagseal Reinforcing Sheet) ,

**Customer Location:** Chemical Plant in Louisiana  
**Application Date:** September 1997

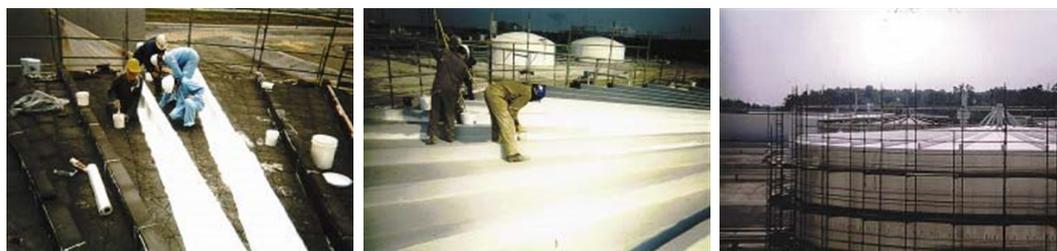
- \* Application begins to the foam glass insulation. ,
- \* Work in progress. ,
- \* The finished application. Seamless encapsulation and waterproof protection to the insulation with Belzona® 3211. ,

Foam glass insulation on roof of 70' diameter tank

The application was carried out in accordance with Belzona Know-How Leaflet TCC-4.

It was necessary to protect the new insulation with a coating impermeable to water but with a certain water vapor permeability to allow any moisture to escape the insulation. The protective coating had to be impact resistant, have no VOC (volatile organic content), and be fire resistant. Belzona® 3211 meets all requirements.
