# BELZONA GIVES A FRANCIS TURBINE A NEW LEASE OF LIFE

Customer Location: Hydroelectric Power Plant, Czech Republic

Francis turbine runner

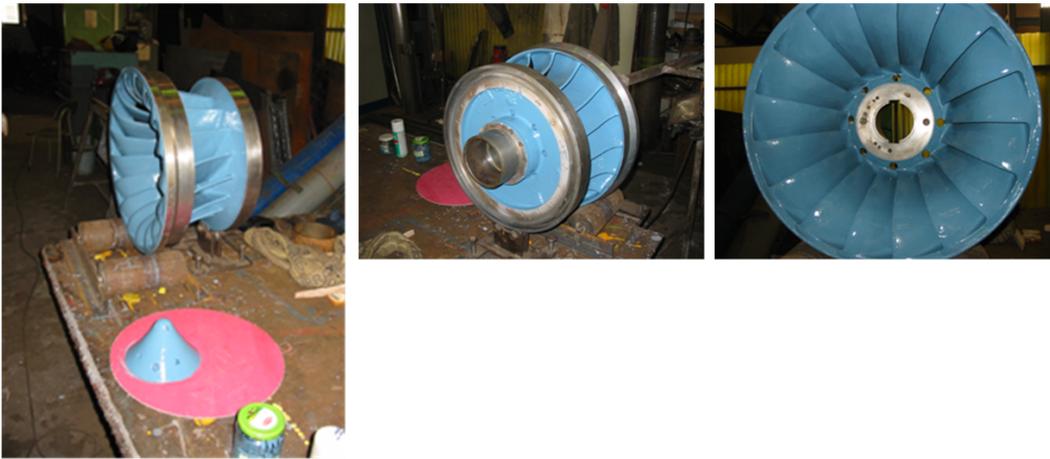
The working surfaces on the runner had suffered from erosion causing the turbine to lose efficiency.

- \* The Turbine runner ,
- \* After application ,
- \* Coated with Belzona® 1341 ,

Application was carried out in accordance with Belzona Know-How System Leaflets CEP-8 and CEP-10.

Belzona was chosen to protect the turbine from the erosion and corrosion for its ability to increase the efficiency of the turbine.
