# BELZONA PROTECTS HYDROELECTRIC TURBINES

ID: 710

Customer Location: Hydroelectric Power Plant, Czech Republic

Two Kaplan Turbines

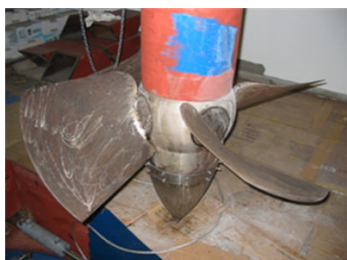
Erosion caused by entrained particles in the water, there was also corrosion damage present.

\* 1. Damaged Turbine 2. Application Situation 3. Coated Blades 4. Completed Application ,

The application was carried out in accordance with Belzona® Know-How System Leaflet CEP-10.

Belzona® 1341 was chosen for its excellent erosion protection, as well as enhancing the efficiency of the turbines.
