# BELZONA QUICK EFFICIENT SOLUTION FOR FACTORY FLOOR

ID: 7472

**Customer Location:** Sausage skin factory, Hanko, Finland  
**Application Date:** March 2017

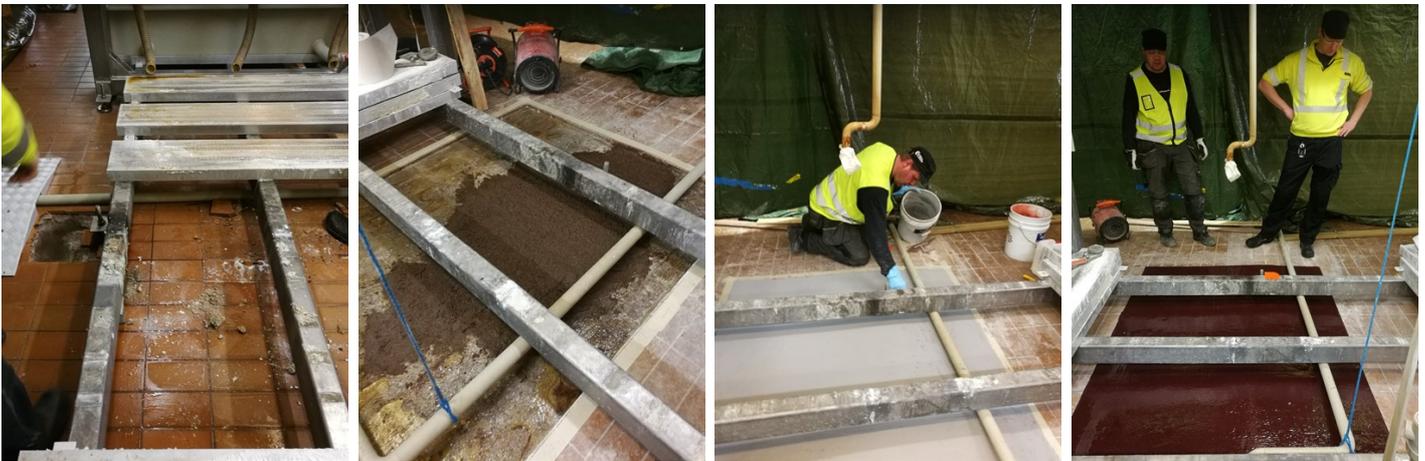
Chemicals were damaging the floor and attacking the grout between tiles. This particular problem area was a 3-4m<sup>2</sup> area underneath equipment with leakages. The repair had to be carried out in a 3 day window.

- \* 1. Damaged tiles under equipment ,
- \* 2. Belzona 4154 applied to infill deepest damage ,
- \* 3. Application of Belzona 4111 to restore original levels ,
- \* 4. Belzona 4311 coating applied for chemical resistance ,

Application was carried out in accordance with Belzona system Leaflets FPA-1 and FPA-3. Belzona 4154 was used to fill the larger, deeper areas (up to 100mm). Belzona 4111 was then applied before coating with Belzona 4311 to give a chemical resistant layer to prevent further chemical attack.
