BELZONA PROTECTS SUGAR MILL DIFFUSER FROM ABRASION DAMAGE

ID: 7473

Customer Location: Sugar Mill, Arcis Sur Aube, France
Application Date: November 2016

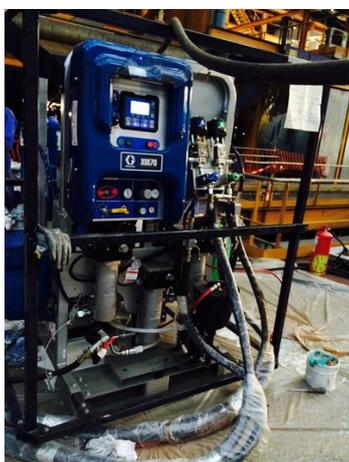
- * Image 1 - The plural airless spray purchased by the Distributor to complete the application ,
- * Image 2 - The sugar diffuser ,
- * Image 3 - QR code for application video ,

The application procedure completed using a modified version of the system leaflet, TCC-5. The application saw 120-150 litres of Belzona 1381 applied to the diffuser at the ideal thickness of 1000 microns. A plural airless spray was used cover the region of over 100m², split into 10m² patches. The application took 5 hours to spray apply but 10 days in total for rotating the diffuser to allow access and for surface preparation.

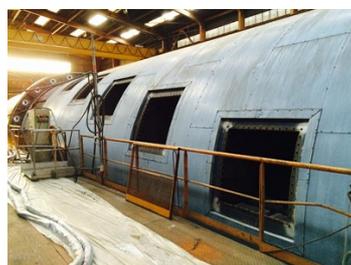
Sugar diffusers are notoriously difficult to protect because they offer limited access. However, they are highly susceptible to abrasion, accelerated by the high temperature of the water (up to 90°C (194°F)) and an added chemical. Therefore, protection is often necessary.
